District: 14 County: 105 Cont-Sec: RR00-00 Structure: 001 Route: Ruby Ranch Rd.
 Feature Crossed: Onion Creek Inspector: Charles T. Stone, P.E. Date: 11/19/2014
 Company Name: Stone Structural Engineering (F-192) Maintenance Section: HOA

Bridge Inspection Record

District: 14 County: 105 Cont-Sec: RROO-00 Structure: 001 Route: Ruby Ranch Rd.
 Description: 4- simple span Prestressed Concrete Beam Bridge on concrete cap & column supports.
 Feature Crossed: Onion Creek Inspector's Signature: [Signature] Date: 11/19/2014
 Company Name: Stone Structural Engineering (Texas Firm Reg. F-192)

4- simple span Prestressed Concrete Beam Bridge on concrete cap and two-column concrete supports.

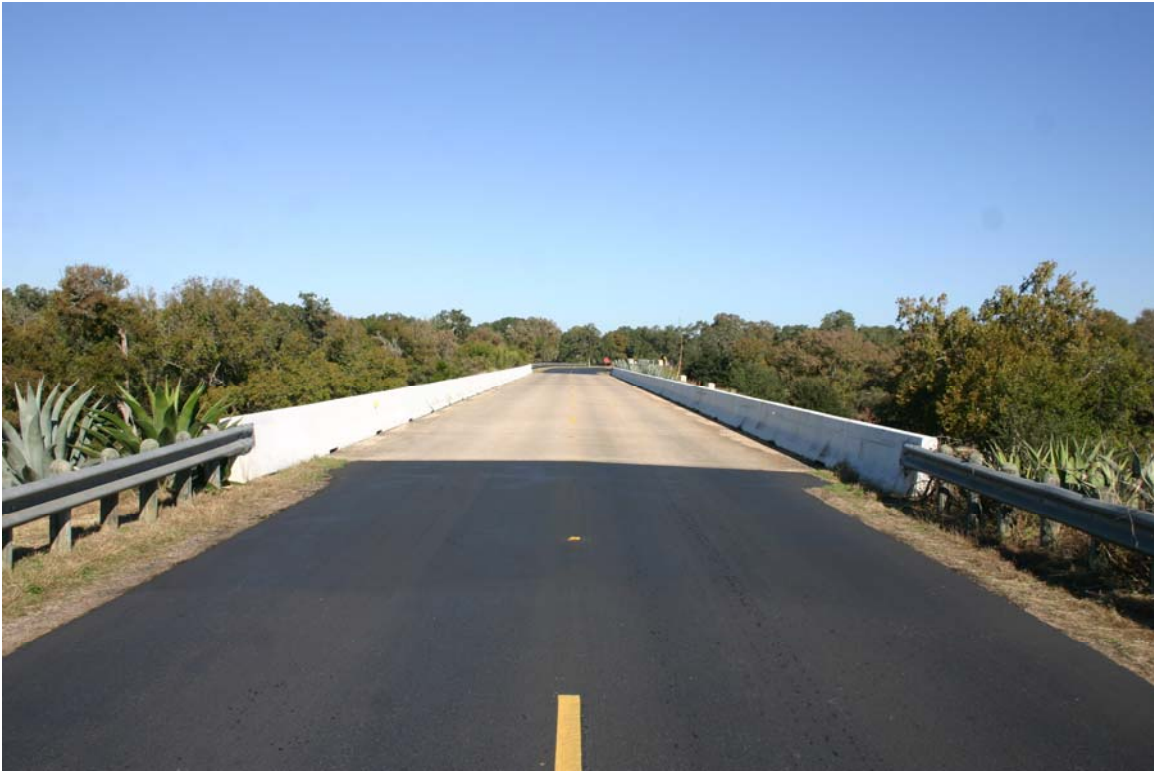
Photo 1

ROADWAY OVER BRIDGE

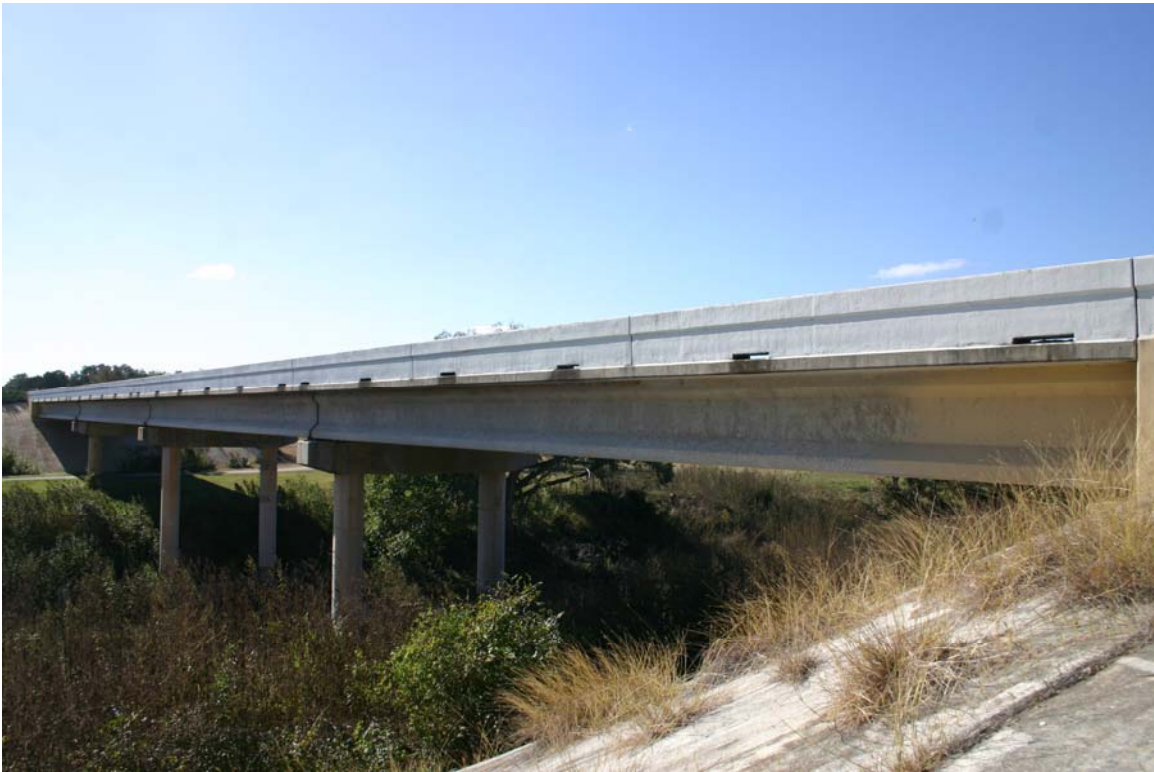
Photo 2

ELEVATION

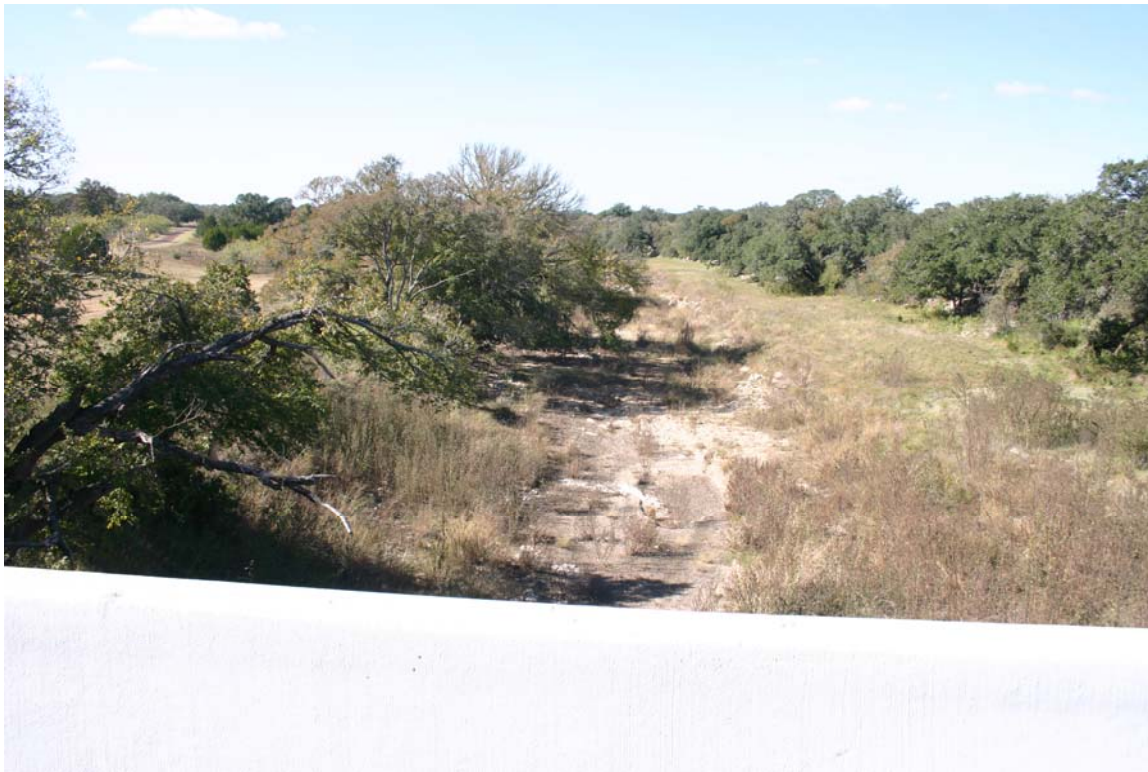
Photo 3

UPSTREAM VIEW
FROM BRIDGE

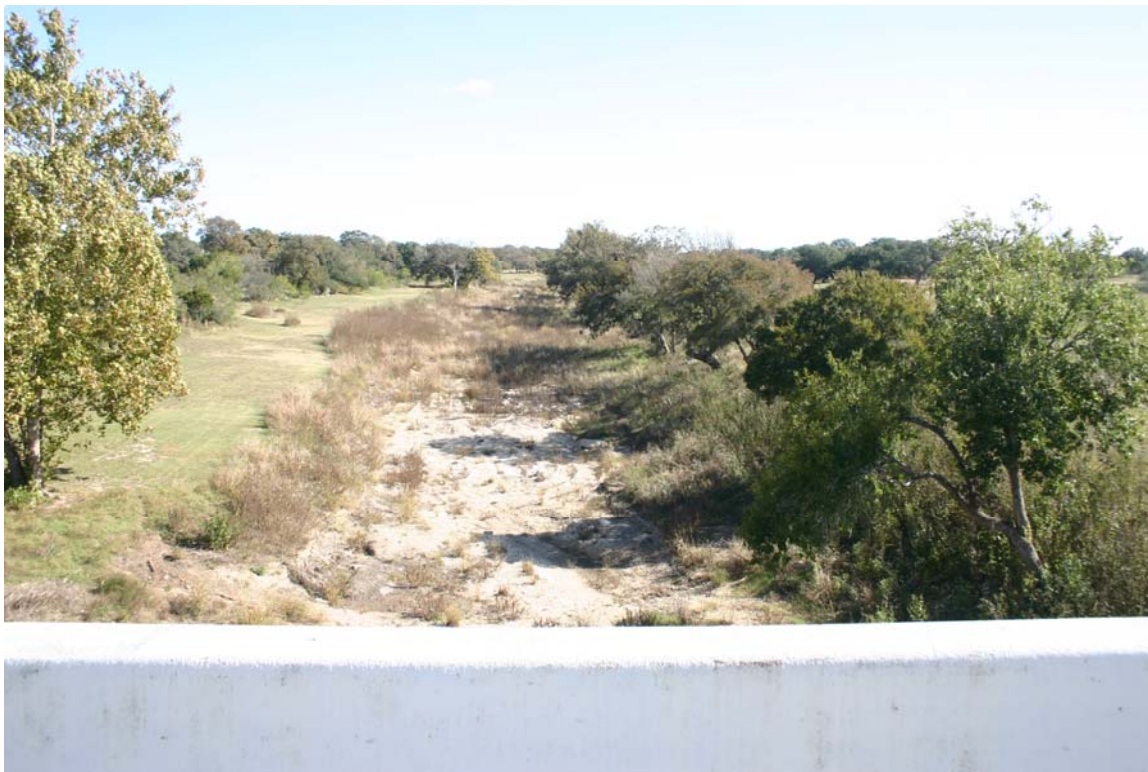
Photo 4

DOWNSTREAM VIEW
FROM BRIDGE

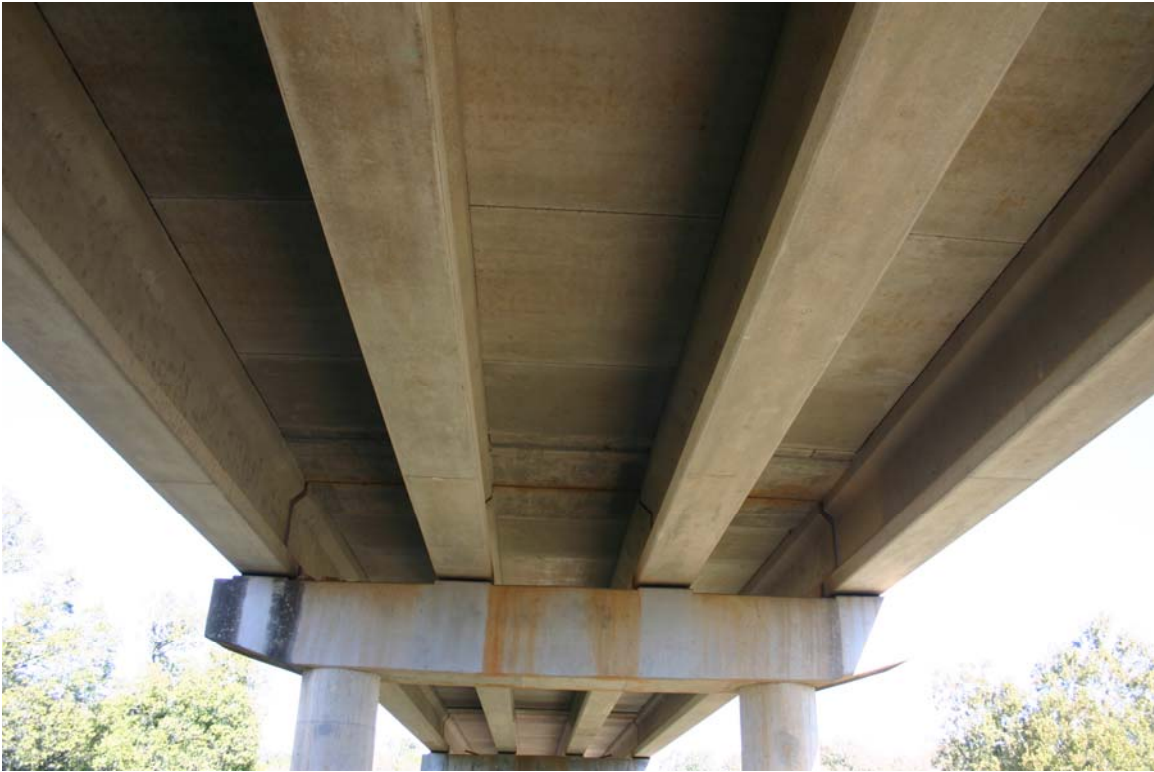
Photo 5

SUPERSTRUCTURE

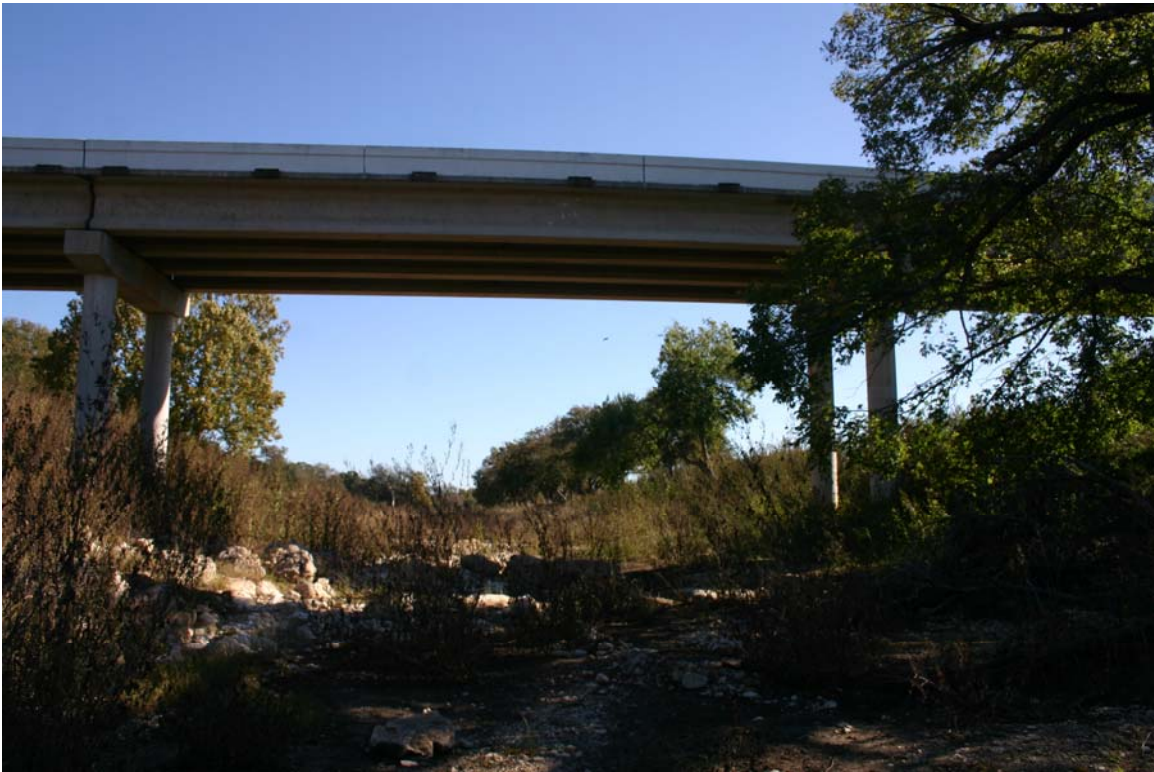
Photo 6

STREAM UNDER BRIDGE

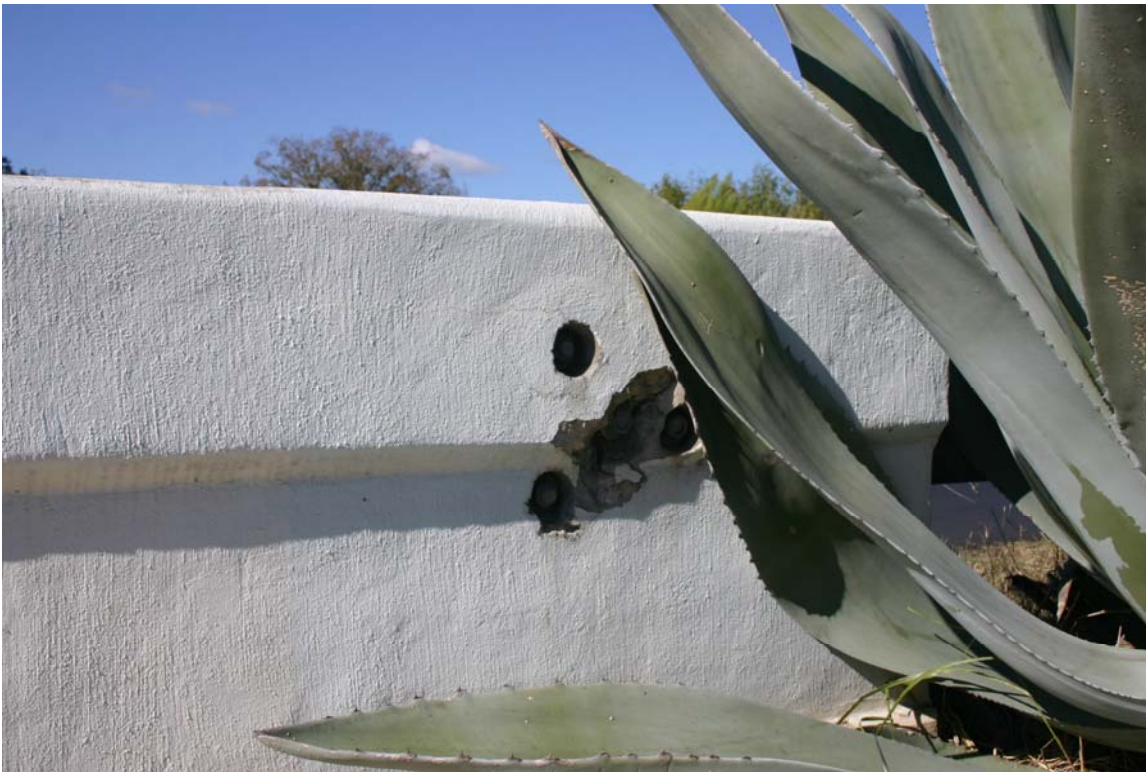
Photo 7

BRIDGE RAIL SPALLS AT NE TRANSITION

NOTE: A few very minor spalls in the outside face of the concrete bridge rail at the NE approach guardfence bolted rail transition connection.

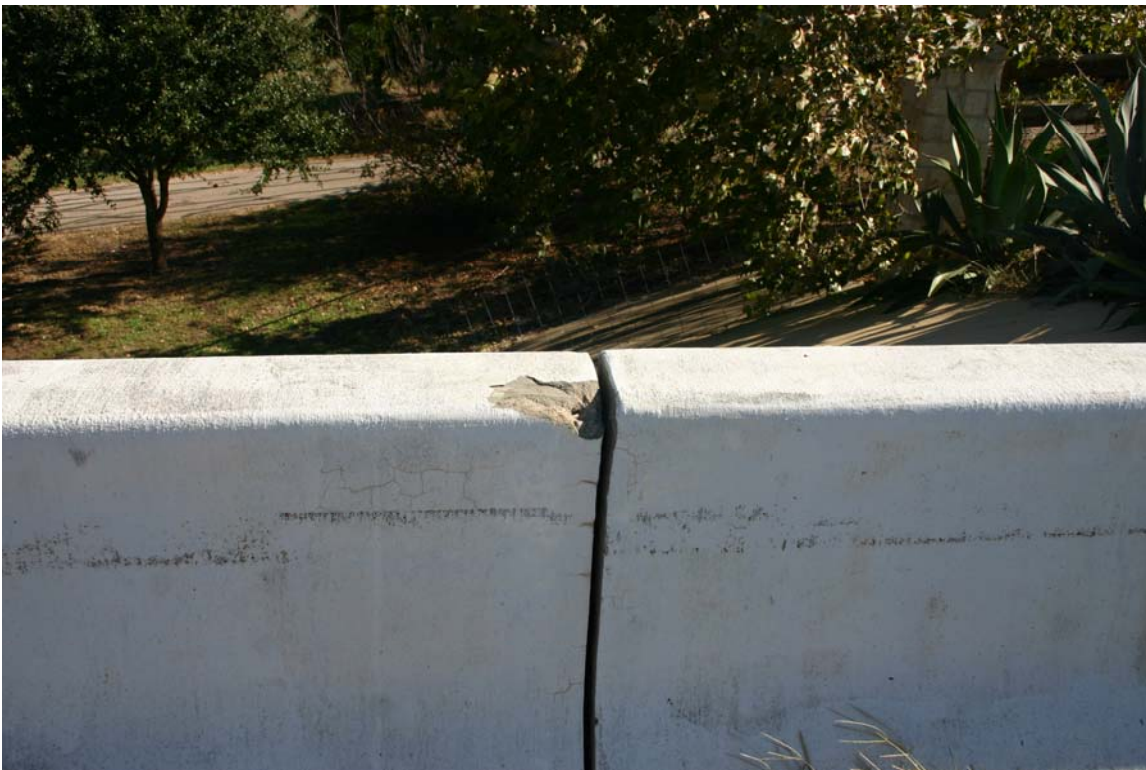
Photo 8

BRIDGE RAIL SPALL AT SE BRIDGE CORNER

NOTE: Very minor shallow cosmetic spall in the top of the concrete bridge rail at the SE bridge corner.

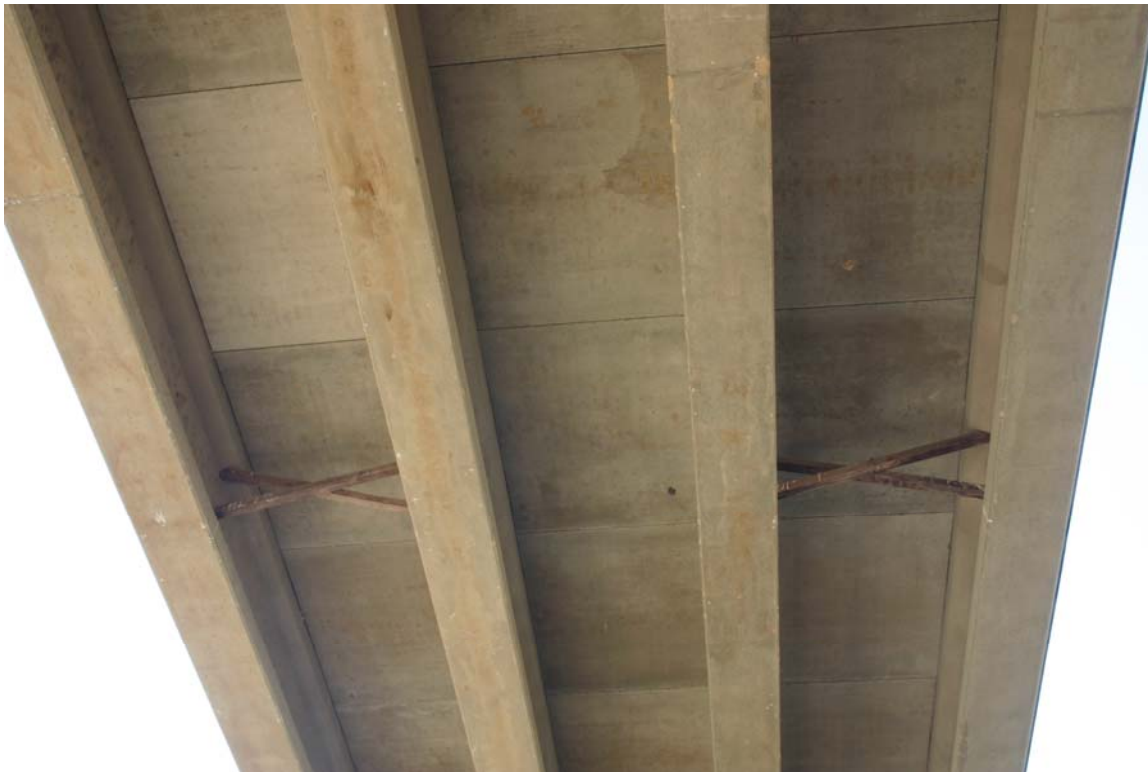
Photo 9

REMAINS OF TEMPORARY
CONSTRUCTION BRACING

NOTE: Two temporary timber construction x-braces remain in the 2nd span from the North over the creek channel.

- Prestressed concrete beams are in very good condition. Two temporary timber construction x-braces remain in the 2nd span from the North over the creek channel. (See Photo #9).

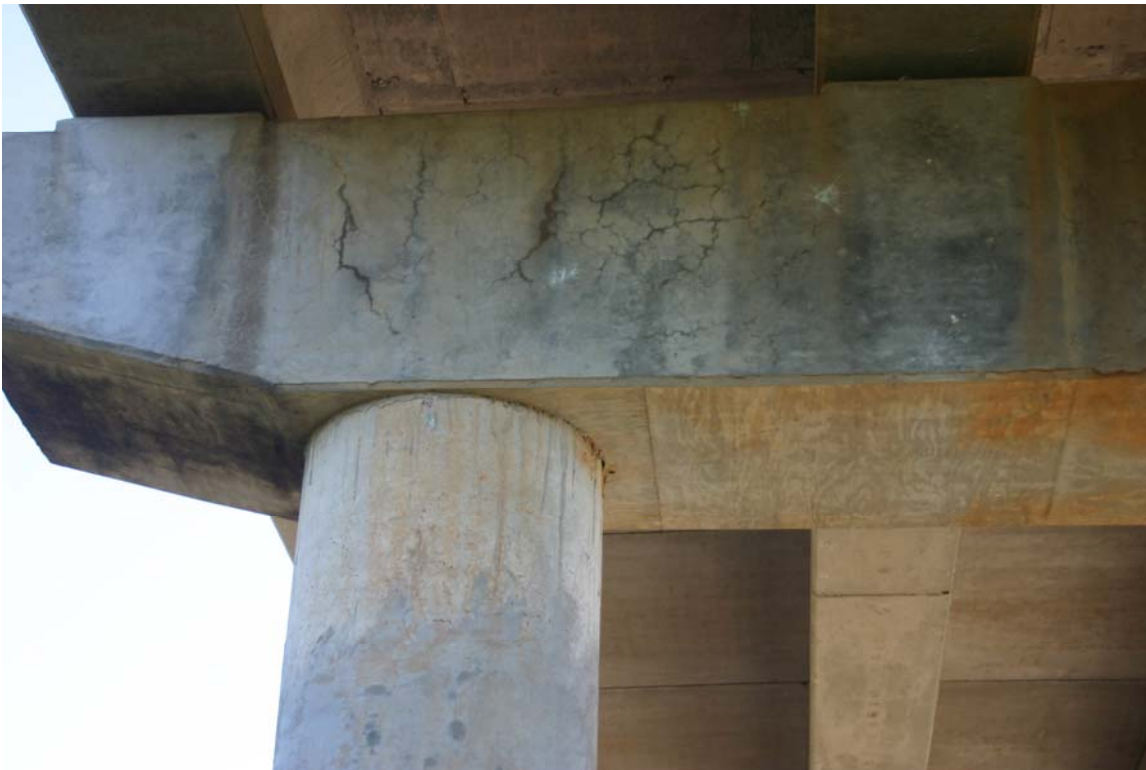
Photo 10

CRACKING IN MIDDLE
BENT SUPPORT

NOTE: Typical minor vertical to diagonal cracking and some "map-cracking" of the middle bent cap support over both columns. No significant loss of strength has occurred as a result of this condition.

1. A few insignificant vertical cracks in the abutment backwalls.
2. Minor vertical to diagonal cracking & some "map-cracking" in the middle bent cap over both columns. (See Typical Photo #10). No significant loss of strength due to this condition.
3. Insignificant scaling and abrasion of the concrete columns and tie-beams in the splash-zone of the middle and North interior bent supports.

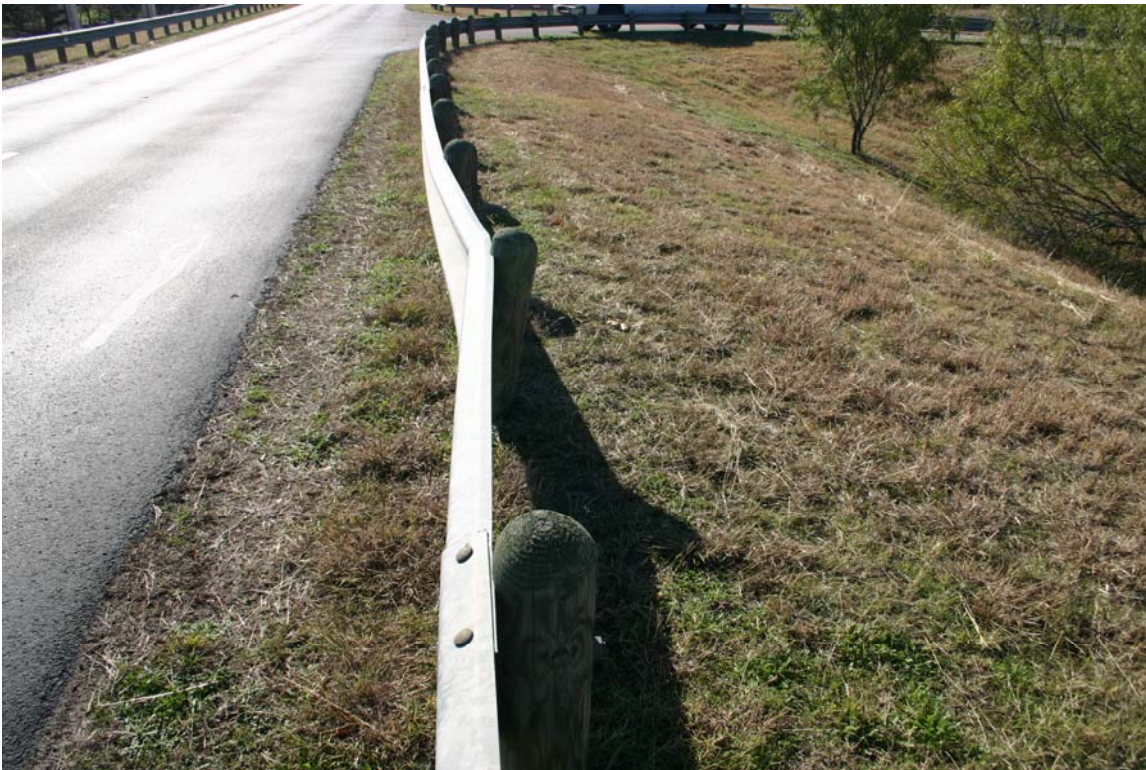
Photo 11

IMPACT DAMAGED SW
APPROACH GUARDFENCE

NOTE: One 25 ft. section of the SW approach guardfence (located ~ 60 ft. South of the SW bridge corner) has moderate deformations due to impact.

1. Minor settlement (less than 1") in the concrete rip rap adjacent to the NE corner wingwall.
2. Asphalt approaches have recently been sealed. A few minor sealed cracks in the North asphalt approach.
3. Moderate impact damage to the SW corner approach guardfence. (See Photo #11).
4. One amber delineator is faded on the East bridge rail.
